Novel testing procedures for tidal composite blades

Jean-Baptiste Jorcin, 05/09/2023, Bilbao

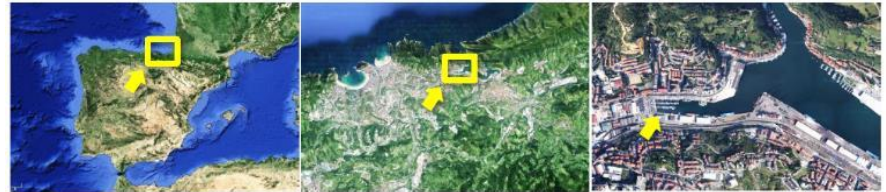
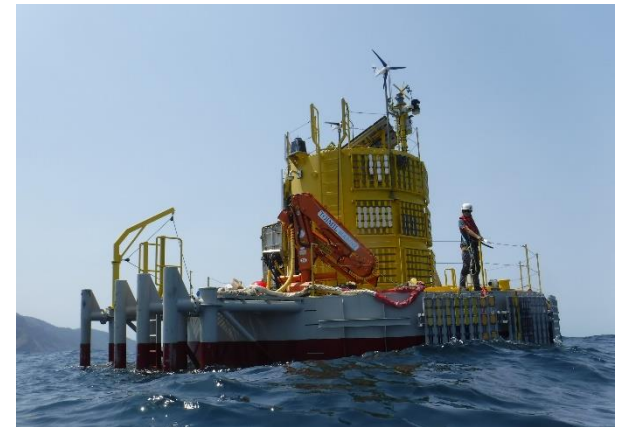
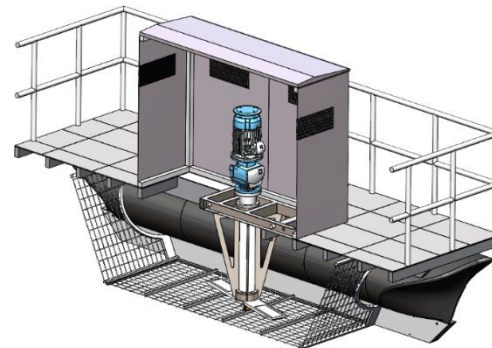
- **Natural ageing:**
 - **Port of Pasaia (Tecnalia facility)**
 - **Harshlab (Tecnalia facility)**
- **Dynamic fouling test system (DCU facility)**

Samples exposed in immersion (1m deep under the lowest surface point) for 10 months with 2 intermediate inspections.

Samples exposed along the length of the blades → change of hydrodynamic conditions
Samples exposed up to 24 weeks with intermediate inspection

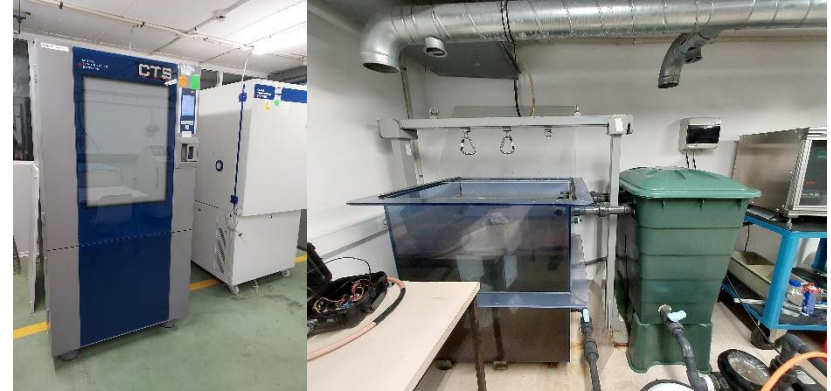
- Artificial ageing:
 - Accelerated ageing in laboratory (Tecnalia facility)

Day 1	Day 2	Day 3	Day 4	Day 5	Day 6	Day 7
Aging media	Condensation 24h	Condensation 24h	Immersion seawater 24h	Immersion seawater 24h	Immersion seawater 24h	Immersion seawater 24h	Immersion seawater 24h
Temp.	T=50°C	T=50°C	T=30 °C	T=30 °C	T=30 °C	T=30 °C	T=-2 °C
Radiation	12h UVA 340, 0,68 W/m2 12 h OFF	12h UVA 340, 0,68 W/m2 12 h OFF

Day 1	Day 2	Day 3	Day 4	Day 5	Day 6	Day 7
Aging media	Immersion seawater 24h	Immersion seawater 24h	Immersion seawater 24h	Immersion seawater 24h	Immersion seawater 24h	Immersion seawater 24h	Immersion seawater 24h
Temp.	T=30 °C	T=30 °C	T=30 °C	T=30 °C	T=30 °C	T=30 °C	T=-2 °C

UV are not relevant

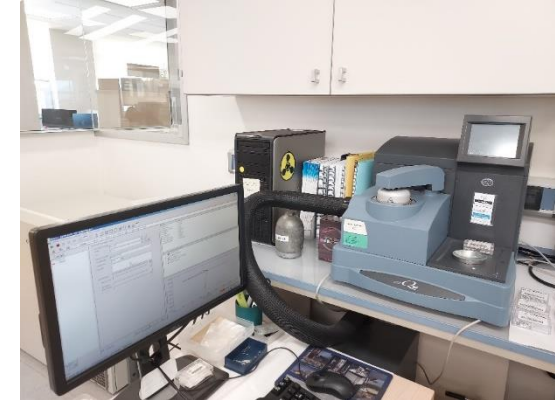
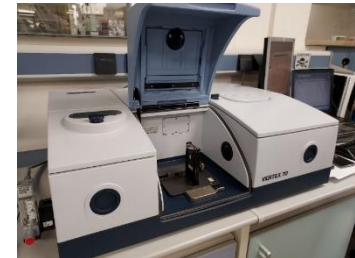
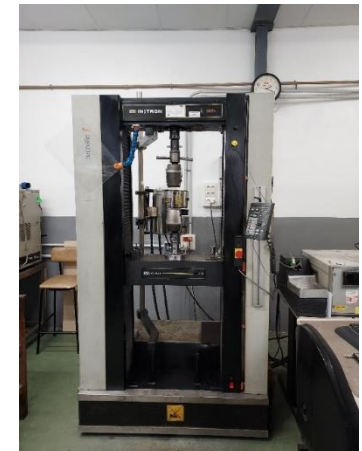
For samples aged in Pasaia, Harshlab and Tecnalia laboratory:

- Gravimetry (water uptake)
- FTIR (evolution of the surface chemistry) → confirmation no effect of UV)
- DSC (plasticization/ change of Tg)
- Tensile test: effect on the mechanical properties

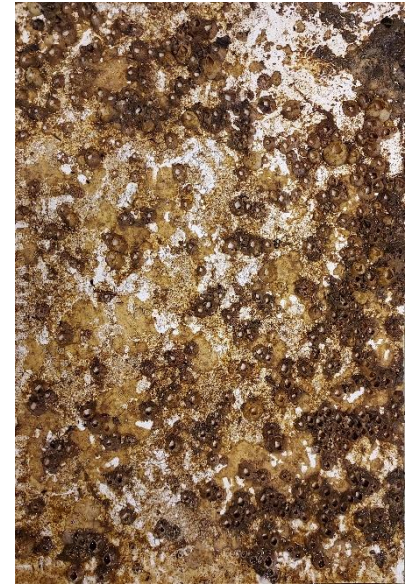
- Image analysis (all the test)
- In the case of fouling growth (Natura ageing in Tecnia and DCU)

→ Use of machine learning based technique to perform the image analysis
