Accelerated ageing test to reproduce the degradation of composite material in sea water

Asset → tidal turbine blade

Material: glass fiber reinforced vinyl ester resin composite with a gelcoat surface finishing

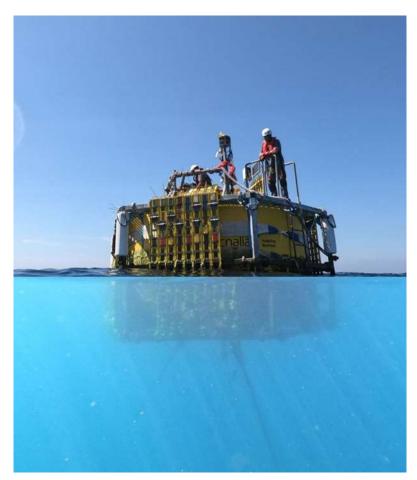
- Port of Pasaia: port environment with high fouling development
- Harshlab: offshore facility for material samples exposition

→ Samples of the composite material will be put in immersion for 10 months in both locations

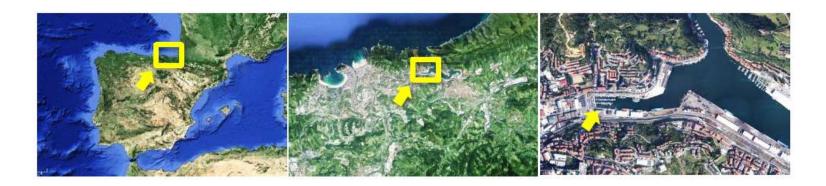
Port of Pasaia: port environment with high fouling development

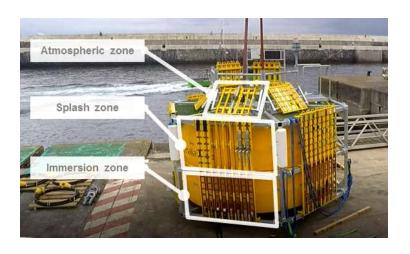
• Harshlab: offshore facility for material samples exposition

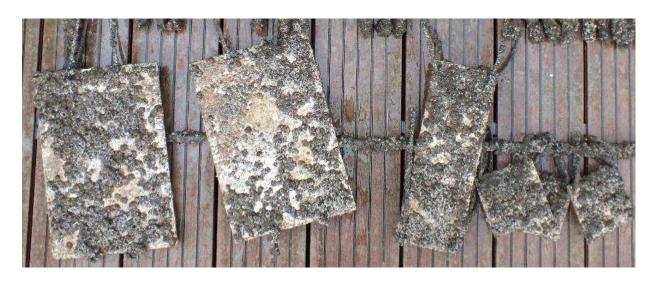
Pasaia

High presence of fooling → need to remove it → it's a challenge not completely solve to do it adequately

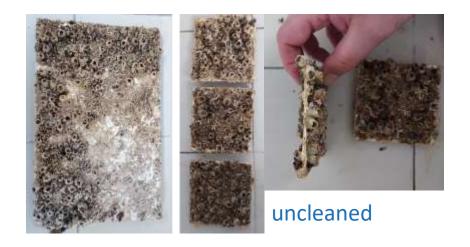
10 months in Pasaia port

cleaned

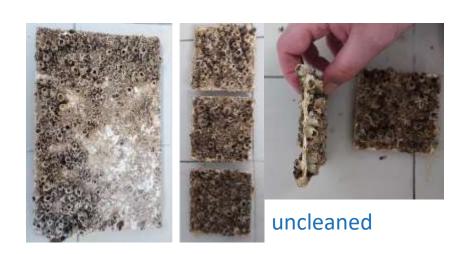
10 months in Pasaia port

High presence of fooling → need to remove it → it's a challenge not completely solve to do it adequately

cleaned

No penetration of the barnacles and other organisms in the material but very strong adherence
