# Accelerated ageing test to reproduce the degradation of composite material in sea water

Jean-Baptiste Jorcin, 05/09/2023, Bilbao

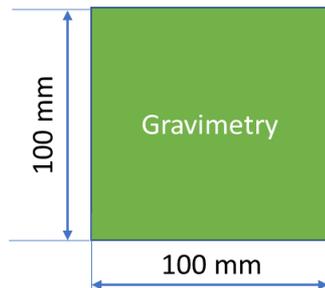
- Gravimetry (ASTM D5229) → mass variation before and after ageing

$$m = (w - w_0) / w_0 \times 100$$

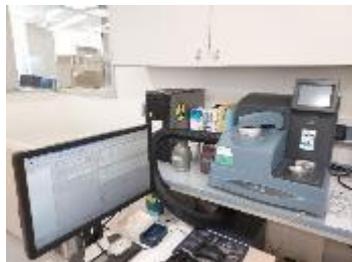
- Differential Scanning Calorimetry (DSC) (ISO 11357)

Samples weight should be in the range 5-100 mg

The DSC → from -90°C to 250°C at 20°C/min

Special interest in T<sub>g</sub> determination

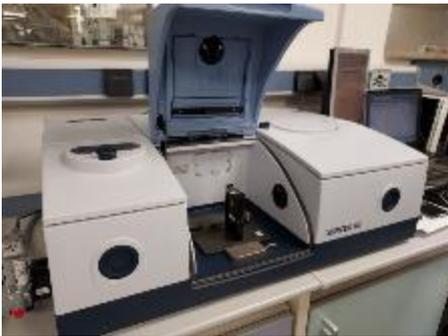
- Fourier Transform Infrared Spectroscopy (FTIR) (ASTM E1252 – 98)

1mg of the samples will be ground into powder with infrared-grade. KBr 100 mg will be used to prepare pellet

Information about the chemical characteristics of the composites polymerization and curing degree) as well as the degradation chemistry (degree of cross linking, scission reactions during aging).

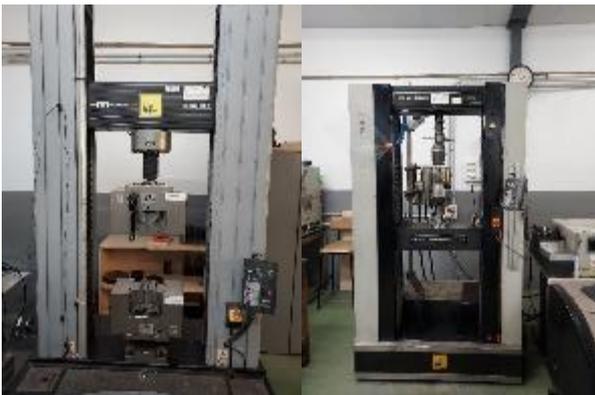
- Tensile test (ASTM D3039)

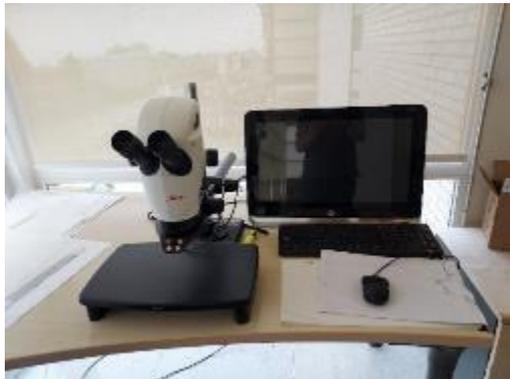
- Optical: binocular and camera

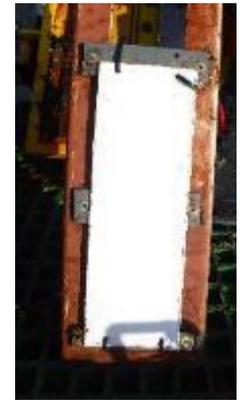
- Samples installed in Harshlab:

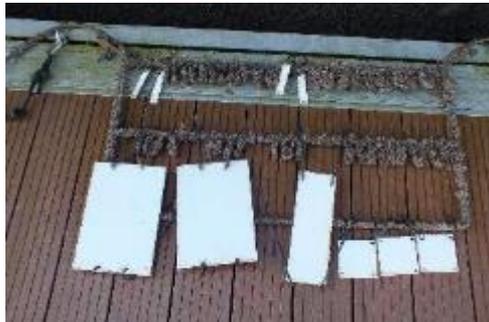
- Samples installed in Pasaia

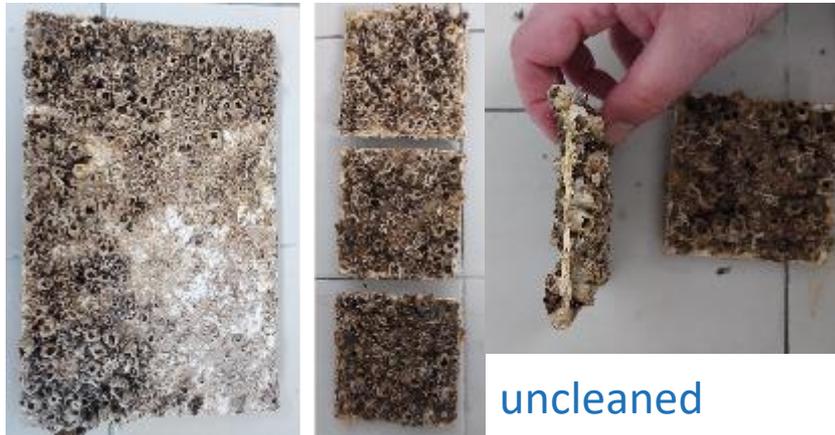
10 months in Pasaia port

- High presence of fouling → need to remove it → it's a challenge not completely solve to do it adequately

**No penetration of the barnacles and other organisms in the material but very strong adherence**

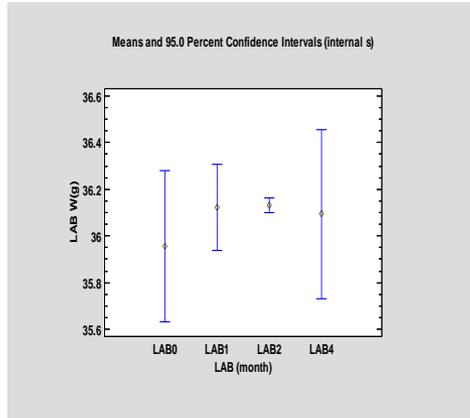
gravimetric measurements on samples taken every month from the accelerated ageing test

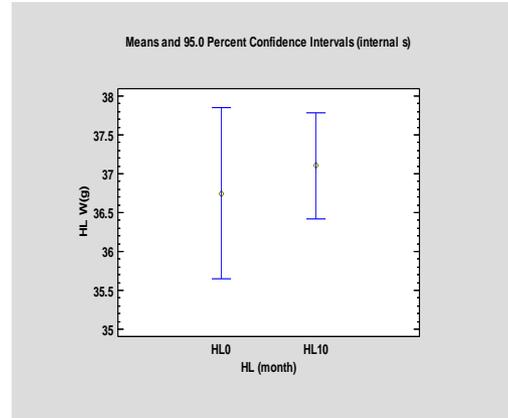
gravimetric measurements done before and after ageing in the HarshLab facility

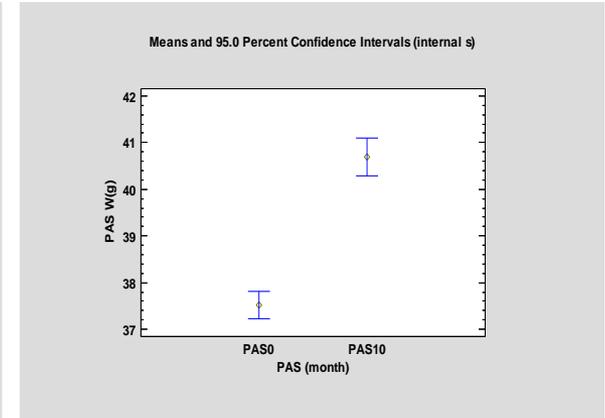
gravimetric measurements done before and after ageing in the port of Pasaia

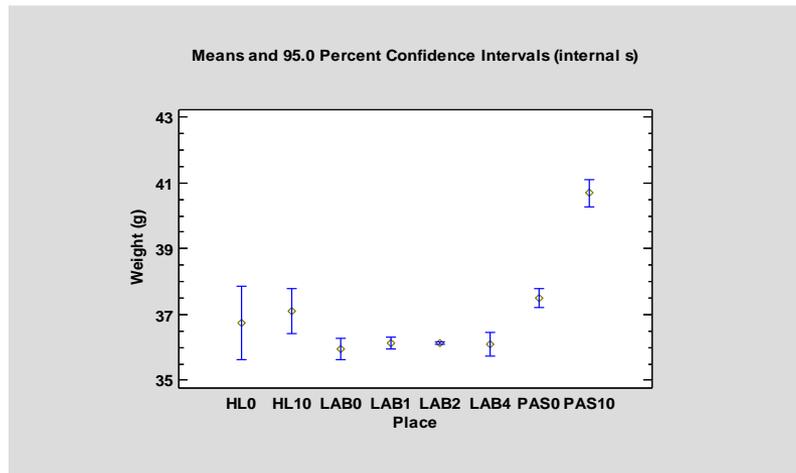
Strongly affected by the “remaining” of the fouling for the naturally aged samples

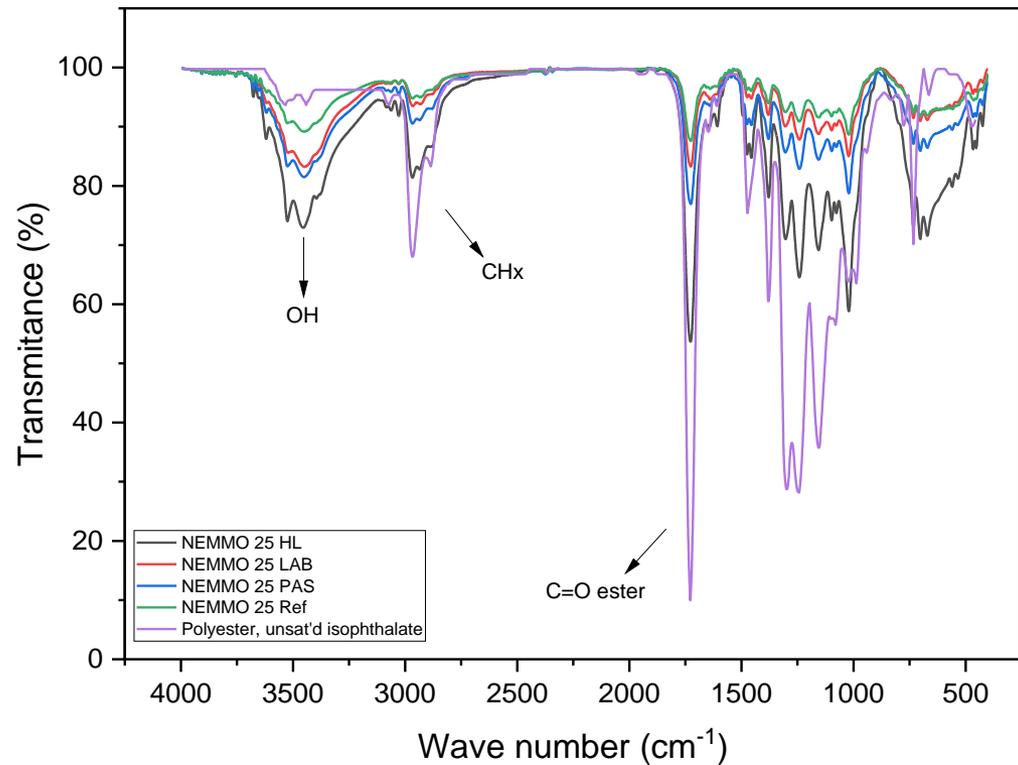
- FTIR

No chemical degradation of the material (no effect of UV)

- The 3 ageing did not affect the IR and DSC spectra  
→ No chemical changes → Low effect of UV
- The 3 ageing did not lead in significant difference in mechanical properties (no plasticization due to water uptake)
- Gravimetry show a slight water uptake in the artificial ageing. In Harshlab and Pasaia, there is a clear increase of weight, but it is due to both water uptake and fouling remaining (hard to clean) → no conclusion can be taken for water uptake
- Fouling cleaning procedure is a big issue and fouling remaining affect many of the characterization methods.

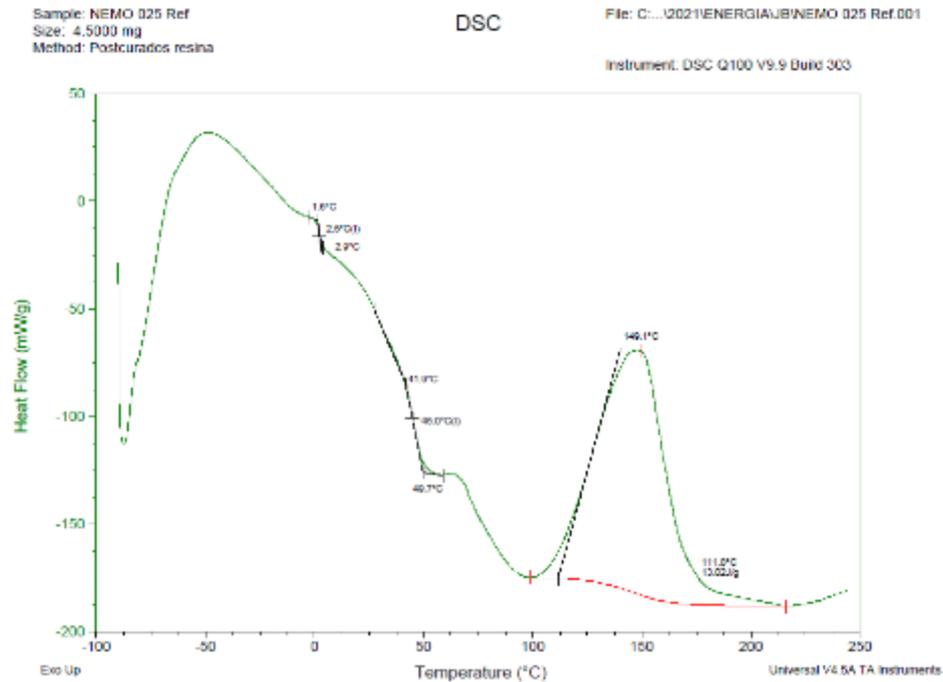
- DSC

The DSC measurement did not allow to get exploitable spectra to extract Tg

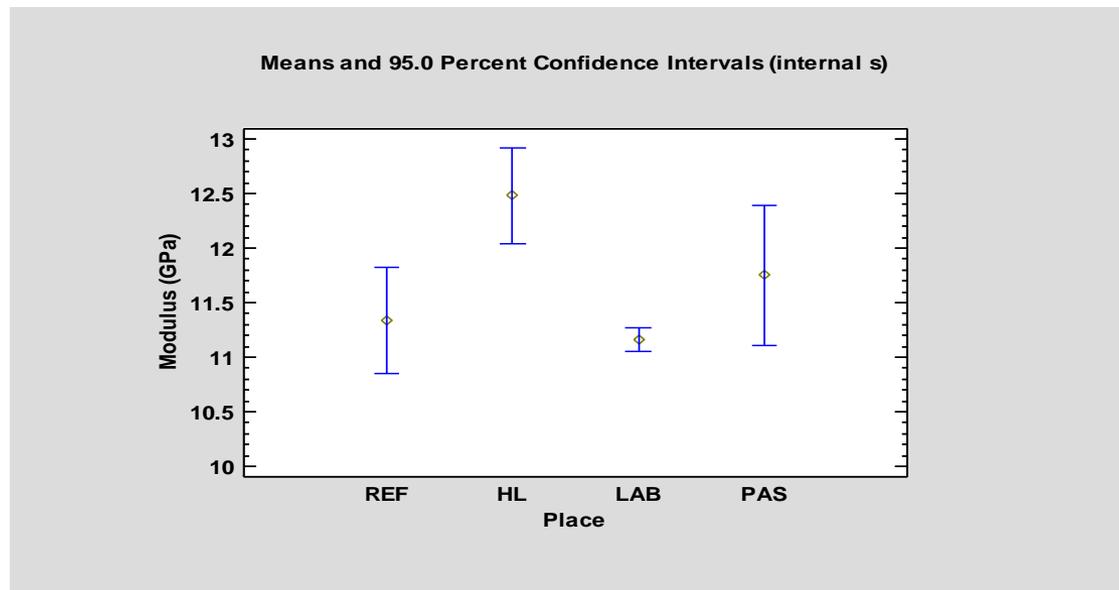
- Tensile tests

No significant variation after between the samples after the 3 ageing
